CLINICAL CASE

Direct cusp covering of vital element with very deep cervical margin

Dr Daniele
Gensini

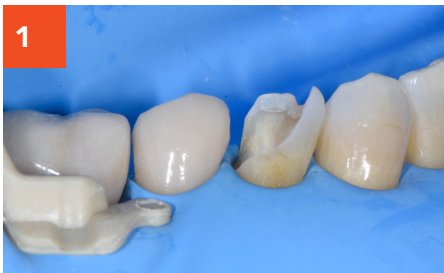
1 Clean cavity with deep cervical margin

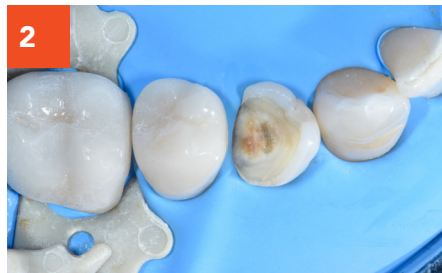
2 Occlusal view. Vital element

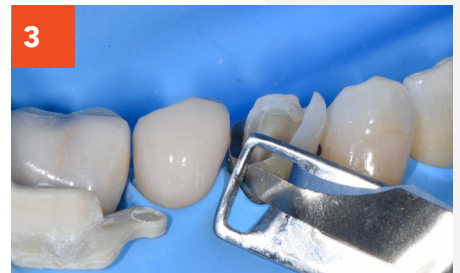
3 Slick Band matrix placement with correct emergence profile

The case presents the need to seal the cervical margin which is in a very deep position, even if it can be isolated with a dam, and to recreate an adequate emergence profile. Thanks to the particular design of the Slick Band matrices, this step was easy and made it possible to bring the restorative margin into a favorable position. Subsequently, after having recreated the direct covering of the missing cusp, thanks to a previously created silicone index, the missing proximal wall was reconstructed thanks to the aid of a 3D Fusion anatomical matrix, very useful for obtaining a correct emergence profile and an appropriate proximal contact point. Finally, the modeling of the restoration was completed and the correct occlusal contacts were checked

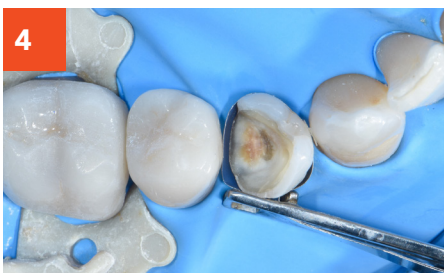
4 Precise adaptation of the matrix to the margin

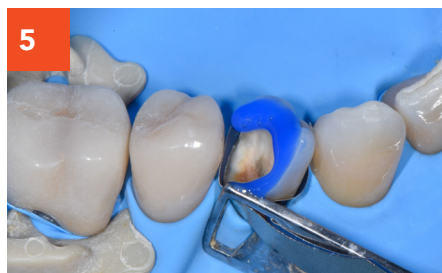
5 Selective enamel etching

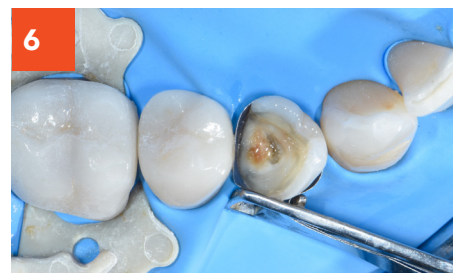
6 Universal adhesive

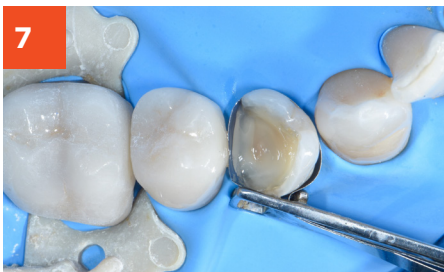
7 Highly filled flowable composite for reconstruction of the deep cervical margin

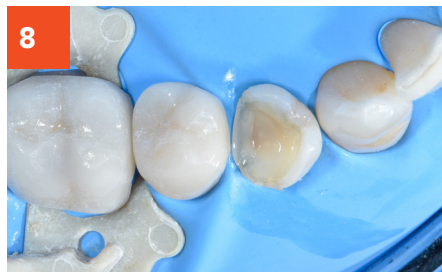
8 Margin sealed and dentin covered with flowable composite

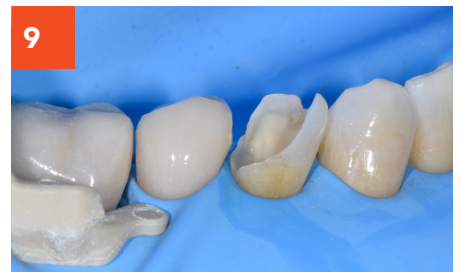
9 Restorative margin in a favorable position and with correct profile

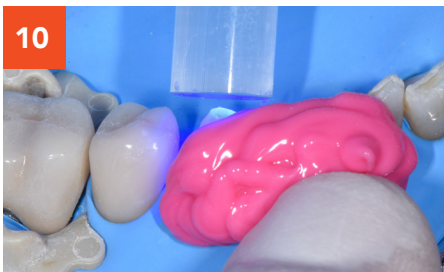
10 Silicone index to reconstruct the missing cusp

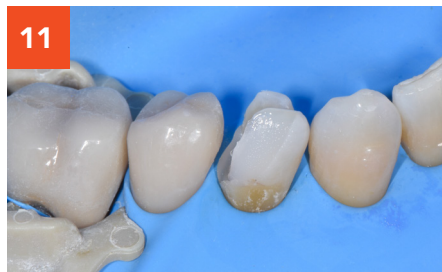
11 Reconstructed stamp cusp

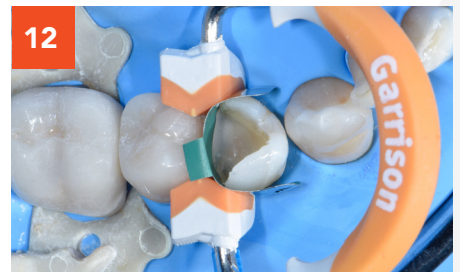
12 Correct adaptation of 3D fusion matrix to the new restorative margin

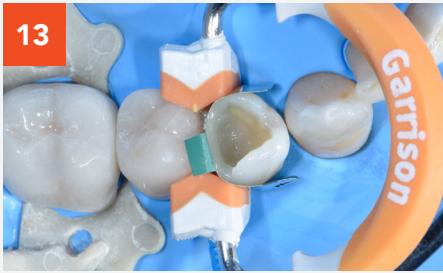
Placement of composite resin for the proximal wall

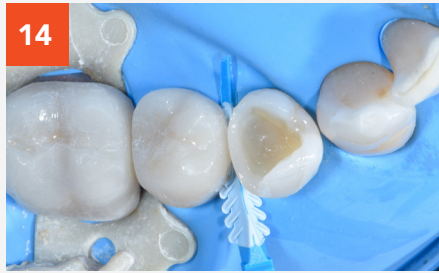
Proximal wall just reconstructed

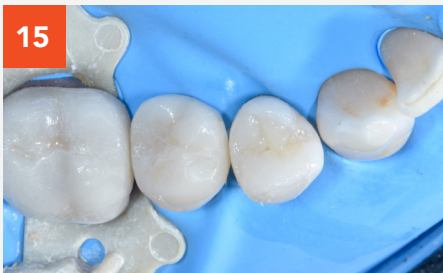
Completion of the modeling of the occlusal table

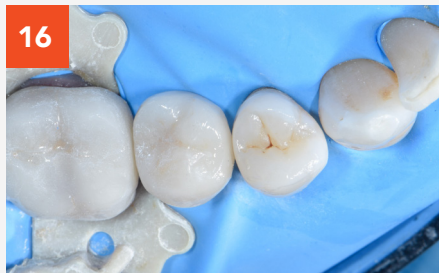
Characterized, finished and polished restoration

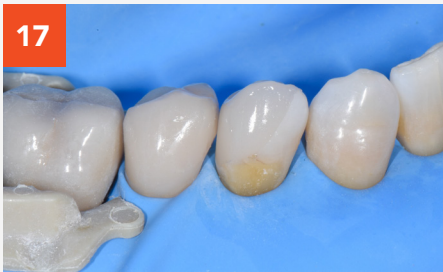
Lateral view of the correct emergence profile recreated

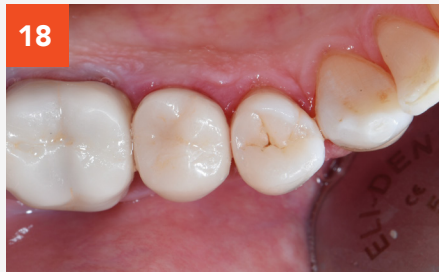
Just removed the rubber dam

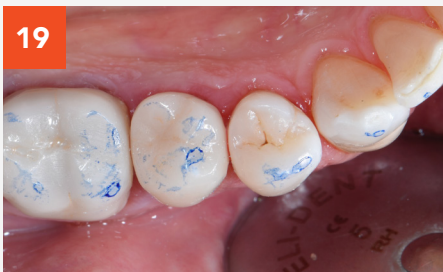
Occlusal check
