CASE STUDY

Direct and indirect rehabilitation
in posterior teeth.

Dr Gianluca
Rossi

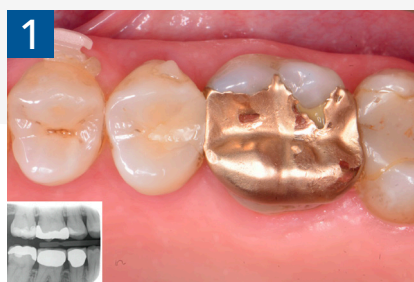
Fig. 1 Preoperative situation. Occlusal view (Rx above)

A patient came to our office, complaining about chewing and thermic discomfort in the upper right jaw. After clinical and radiographic examination, carious lesions on elements 1.7, 1.6, 1.5 and 1.4 have been detected. We chose direct restorations on teeth 1.4 and 1.5 with minimally invasive approach. On teeth 1.7 and 1.6 were instead selected indirect restorations (hybrid composite).

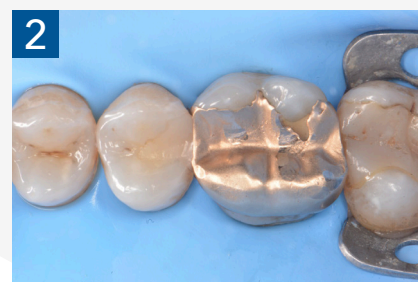
Fig. 2 Isolation with rubber dam of the operative area

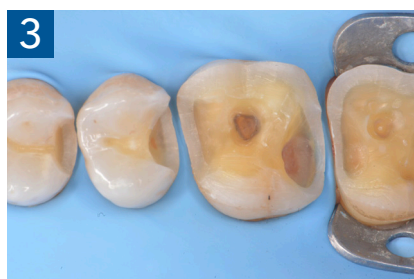
Fig. 3 Teeth after caries removal

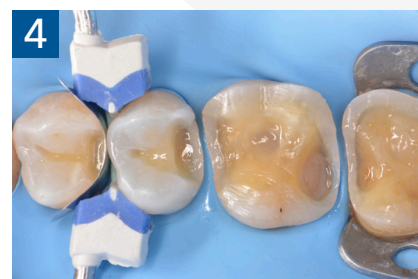
Fig. 4 Restoration of distal wall 1.4 (Garrison Composi-tight 3D Fusion System)

Full coverage overlays were planned on both elements after an accurate biomechanical evaluation of the residual axial wall. After performing the direct restorations using the sectional system Garrison Composi-tight 3D Fusion, the teeth 1.6 and 1.7 have been prepared.

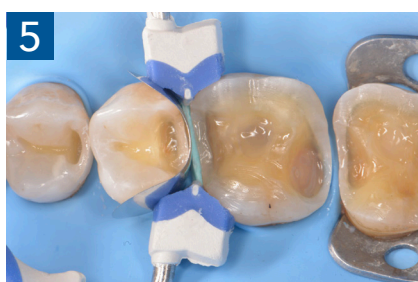
Fig. 5 Restoration of distal wall 1.5 (Garrison Composi-tight 3D Fusion System)

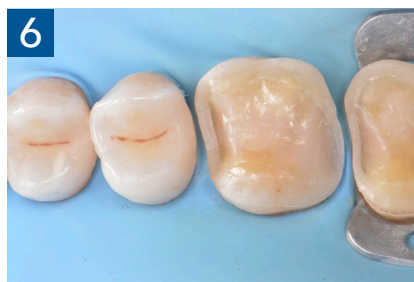
Fig. 6 Restoration 1.4-1.5 completed. Final Preparations 1.6 -1.7

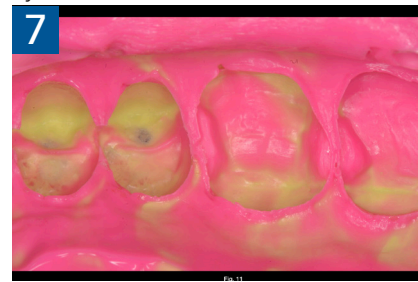
Fig. 7 Impression (Sandwich technique)

The dental impression was taken by single-phase two-component technique.

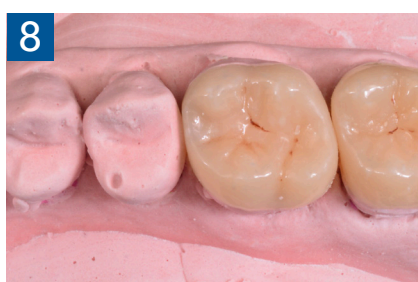
Fig. 8 Master cast. Hybrid Ceramic overlays. (ODT Alessandro Morelli)

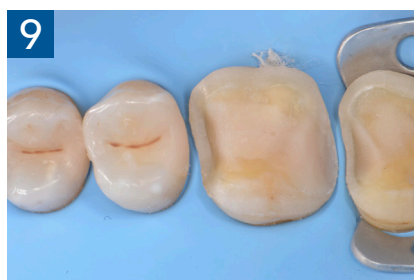
Fig. 9 Cleaned and sandblasted teeth prior to cementation

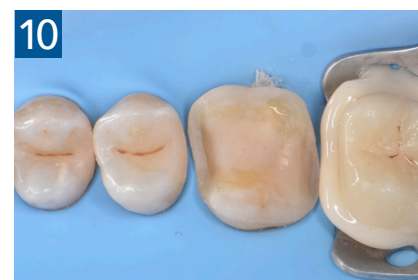
Fig. 10 Luting of the overlay 1.7 with pre heated composite

During the succeeding visit, after isolation of the operative field with rubber dam, the overlays were cemented with pre-heated composite. In this case, the use of this composite facilitated the removal of the excess cement due to the different opacity before and after polymerization. Finishing, polishing and glossing procedures were made before the removal of the rubber dam. Minimum occlusal adjustments were needed.

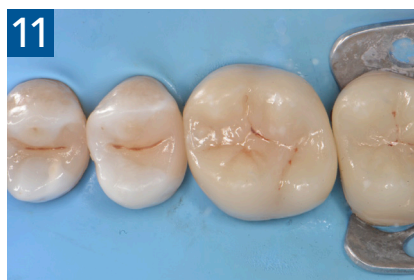
Fig. 11 Final after finishing and polishing procedures.)

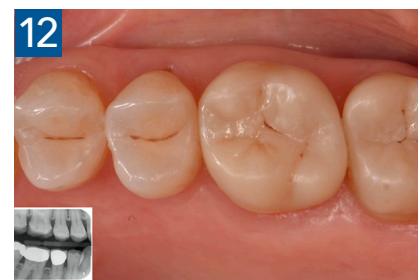
Fig. 12 One month Control. Occlusal view (Rx above)
