## **Simplifying Class II Restorations without an Adjacent Tooth: A Garrison ReelMatrix™ Approach Case Study**

## Simplifying Class II Restorations without an Adjacent Tooth: A Garrison ReelMatrix™ Approach Case Study

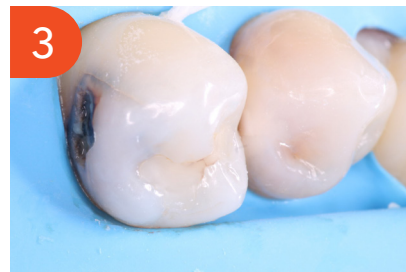
Figure 2: Clinically, a defective restoration and the presence of a carious lesion were observed on the occlusal surface.

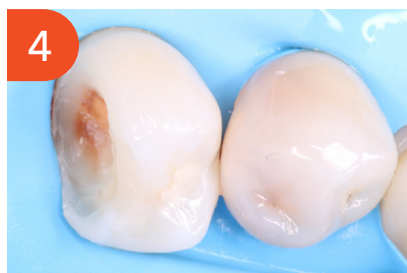
Figure 3: After local anesthesia, absolute isolation was performed using a Nic Tone medium rubber dam.

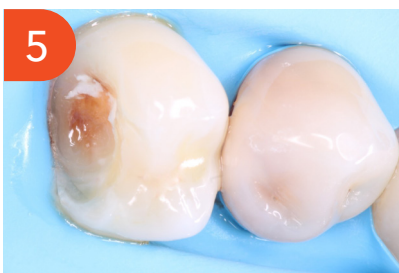
Figure 4: The carious lesion was removed using a high-speed handpiece, followed by manual caries excavation with a dentin excavator.

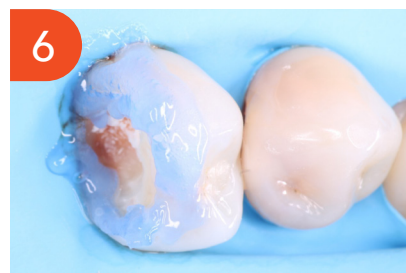
Figure 5: After cavity disinfection with 2% chlorhexidine, TheraCal was applied to the deepest area, closest to the pulp horn, and light-cured.

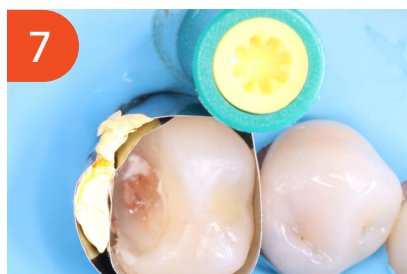
Figure 6: Selective enamel etching was performed with 35% phosphoric acid for 15 seconds, followed by rinsing for twice the etching time and gentle drying.

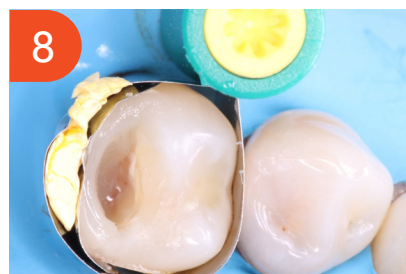
Figure 7: Two coats of universal adhesive were applied with active scrubbing, air-blown between each coat, and then light-cured. A 0.5 mm layer of flowable composite resin was placed on the floor and walls of the cavity and light-cured. The Garrison ReelMatrix™ was then positioned, and a matrix-in-matrix technique was used to achieve better sealing.

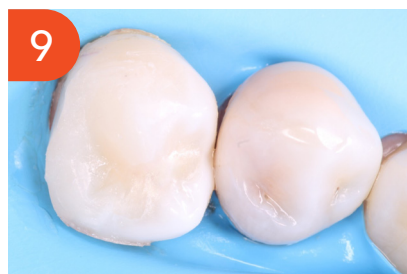
Figure 8: The proximal wall was built using the snowplow technique.

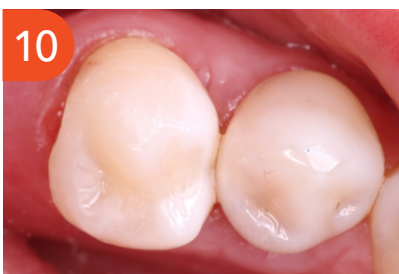
Figure 9: Once the Class II cavity was converted into a Class I cavity, the restoration was completed using a horizontal incremental technique.
