Precision Restorations with the Garrison Quad Matrix System: A Complex Adjacent Class II Case Study

Clinical History:

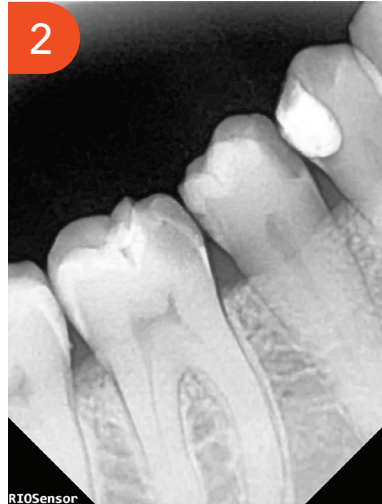
Class II defect (mesial) tooth #45 and #46 with suspected distal Class II defect on tooth #45. Tooth #44 shows discoloration beneath the existing Class II composite restoration, with weak and unsupported walls.

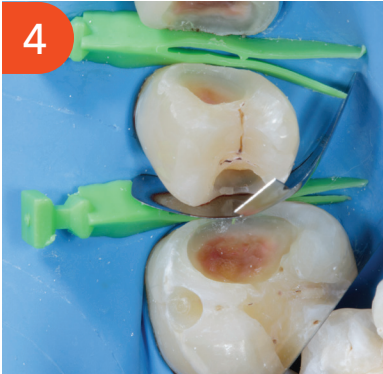
Caries end point removal, achieving peripheral seal zone and removing unsupported enamel. The picture was taken after air abrasion and selective etching was performed. Garrison® Quad Matrix System™ large wedge was placed as prewedging to protect rubber dam.

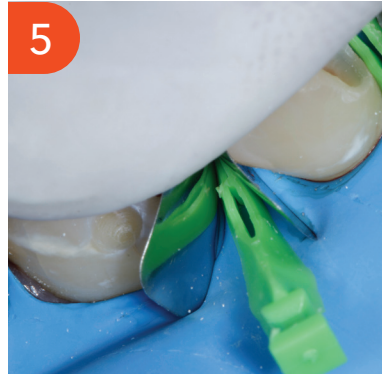
The first band (FXH175) was placed in the distal defect of tooth #45 and secured using a Large Quad Wedge.

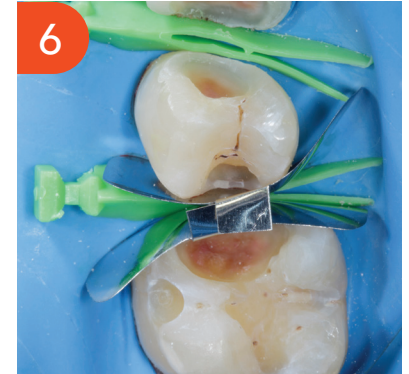
Next, an identical band was inserted into the mesial defect of tooth #46 by slightly repositioning the wedge, allowing the band to pass beneath it. The wedge was then reinserted to its full length, holding the bands in place with gentle finger pressure, ensuring both bands were securely positioned beneath the wedge. The wedge was partially removed, allowing for the molar band to be inserted more deeply using finger pressure.

Both bands are secured with Quad large wedge ensuring tight seal.

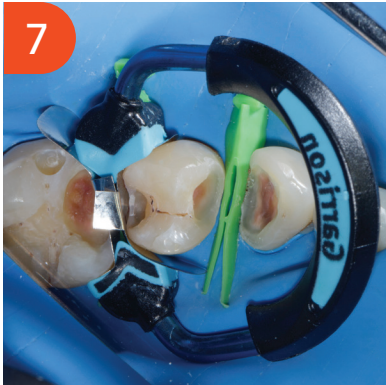
Next, a Quad Universal Ring (blue) was placed between teeth #45 and #46. The ring's unique design works with the Quad wedge to create a tight seal, control excess material, and form a natural contact between the teeth. This combination also allows for efficient restoration of adjacent teeth.

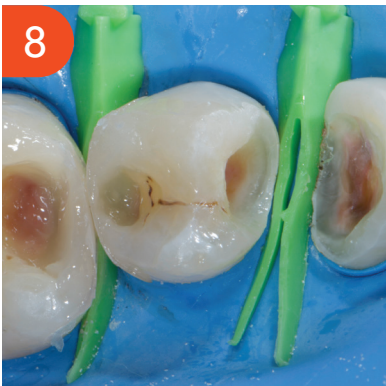
After removal of the ring and band (conversion of the Class II to Class I).

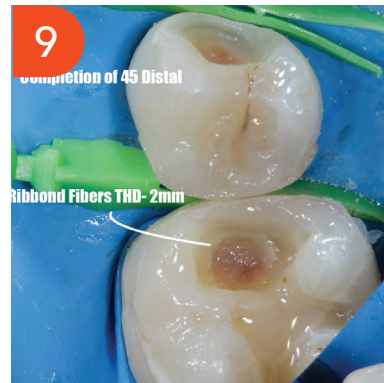
After converting the Class II to Class I, we completed final morphological incremental layering on tooth #45. Since the defect is large on tooth #46, we chose Ribbon fibers (2mm THD) to place inside the proximal box to increase fracture resistance.

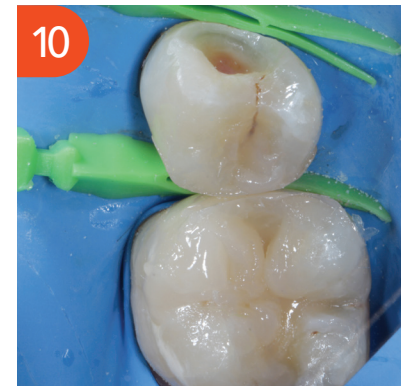
Later we completed cusp by cusp morphological layering for the tooth #46.

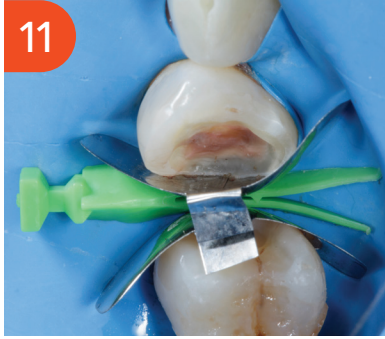
Both bands, FXH175, are secured with Quad large wedge ensuring tight seal.

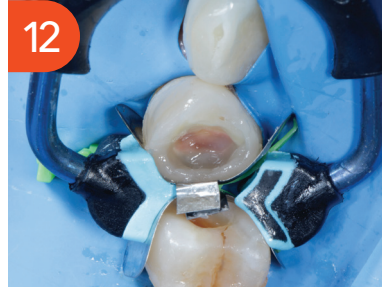
The procedure for placing the ring and following the layering protocol is repeated as described earlier. Quad ring is placed and creating the wall of tooth #44 is completed. The ring is removed along with the band and morphological layering is completed on tooth #44. The ring is again placed and burnished little on adjacent tooth to ensure tight contact post removal of the band. The procedure of making the wall is performed as described earlier.

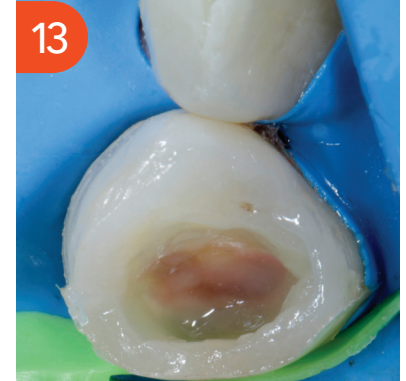
Ribbon placement.

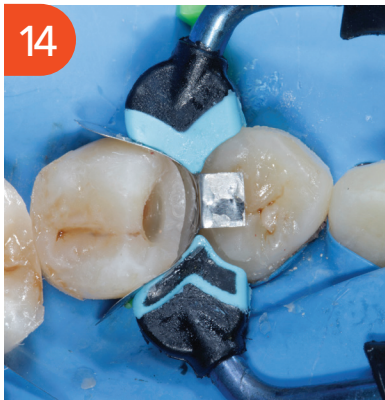
Band is removed from tooth #44 and the wall of tooth #45 is built up.

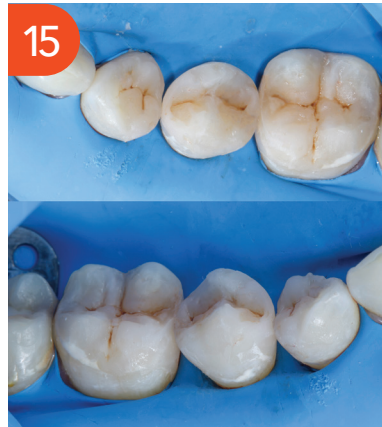
After completion of morphological layering on tooth #45, air abrasion with sodium bicarbonate was used to remove the smear layer.

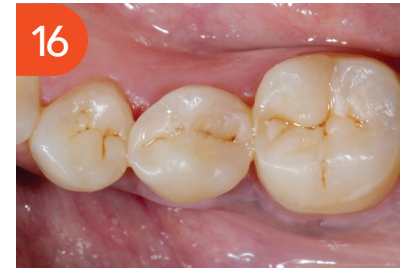
Post op 5 days shows close to natural morphology, contours and contacts.

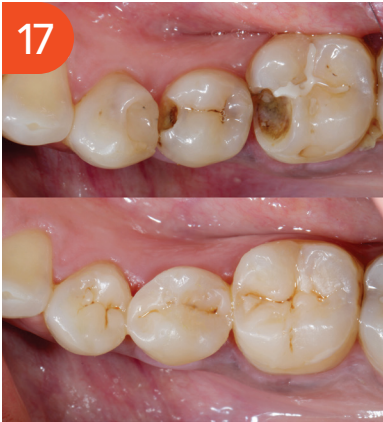
Before and after the treatment.

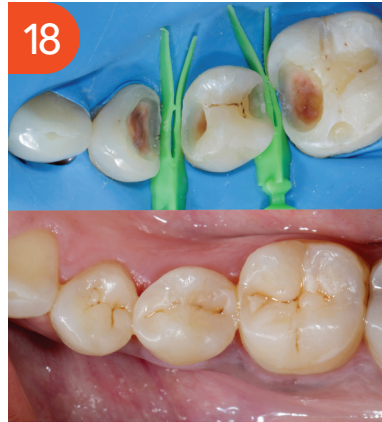
Showing how large defects were built in natural form and function.

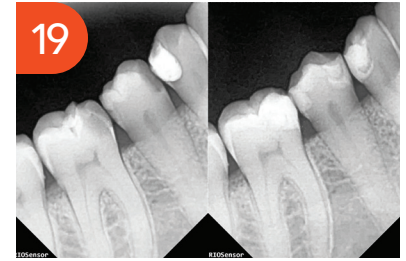
Pre- and post-op IOPA showing contacts and contours. The radiolucency you see in the restorations (teeth #44 distal, #45 mesial, and #46 mesial) is because I used Ribbond.
