CLINICAL CASE

SURGICAL EXTRUSION

Dr Riccardo
Becciani

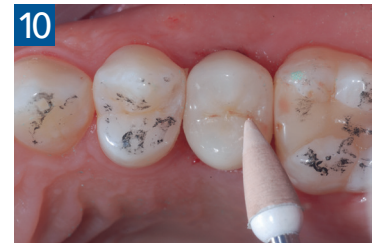
The pass of the eZr Garrison medium-grain green rubber point

After the occlusal adjustment was performed with fine-grained diamond burs, the final polishing is carried out with eZr Garrison rubber polishers. The first step was performed with the coarse-grained blue rubber point to eliminate the micro-grooves created by the diamond bur. Subsequently, the green medium-grained point was applied, which prepares the surface for the final polishing by the orange fine-grained point. Through these simple three steps, a perfectly smooth surface was obtained which is comparable to a glaze. Unlike an unpolished surface which is rather abrasive for the opposing teeth, the mechanical polishing obtained with the eZr rubber polishers produces a shiny and an absolutely brilliant surface which is non-abrasive for the opposing teeth.

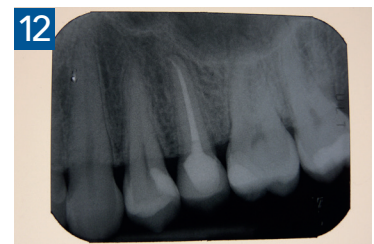
The crown on tooth 25 after polishing with the three eZr Garrison rubber points
