Class II Restoration

MODB #4 and #5

**Class II Restoration MODB #4 and #5**

by: Dr. Robert Rosenfeld, DDS

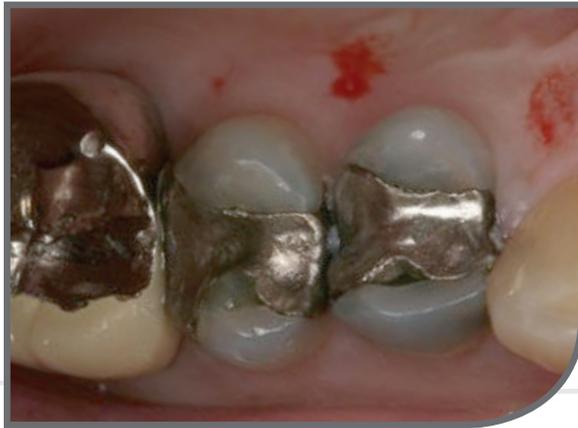
01

Large failing amalgam restorations on teeth numbers 4 and 5, exhibiting marginal leakage and recurrent decay.

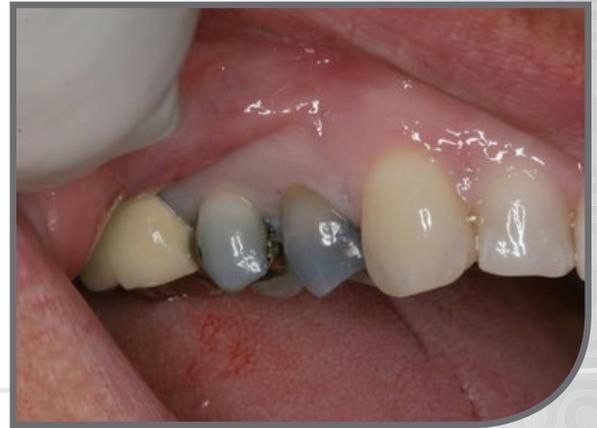
02

Buccal view of teeth numbers 4 and 5, pre-treatment, showing significant discoloration.

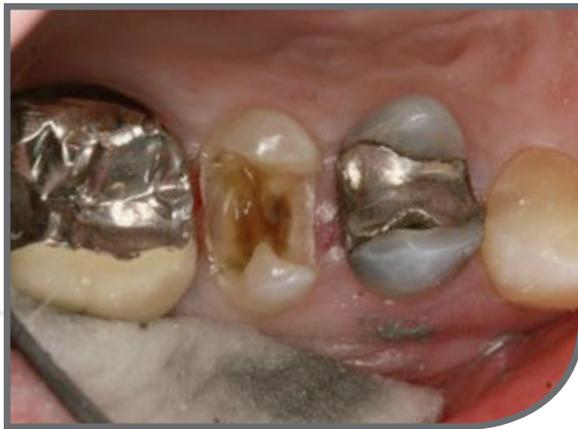
03

Removal of MODB amalgam #4 and excavation.

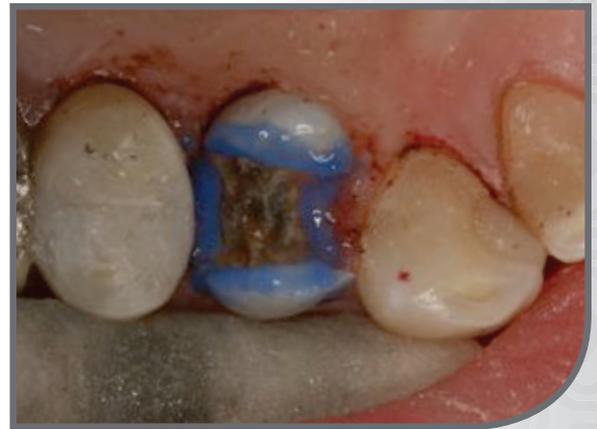
04

Tooth #4 was restored using Composit-Tight 3D rings. I employed a self-etching bonding agent (Clearfil SE Protect, Kuraray) followed by a bulk-filling composite (SureFil SDR, Caulk Dentsply) and then a surface layer of microhybrid composite (Majesty Esthetic, Kuraray). Crude anatomy has been created. Next, I prepared to fill #5. A more certain marginal seal to enamel can be obtained by selectively etching enamel margins with phosphoric acid as shown.

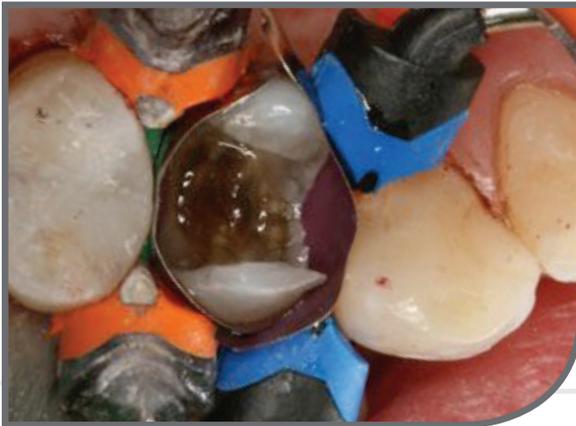
05

Set-up of Composit-Tight matrices, wedges and rings. The original 3D ring works fine on the distal, where clinical crown height is adequate. With shorter teeth, or distals of cuspids, the 3DXR ring is ideal because the tines on blue pad "hook" under wedge, securing it in place and preventing ring pop off.

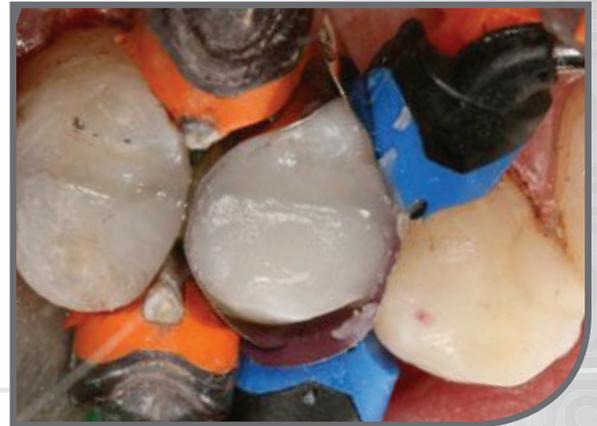
06

Crude buildup of #5, also using Clearfil SE Protect, SureFil SDR, and Majesty Esthetic.

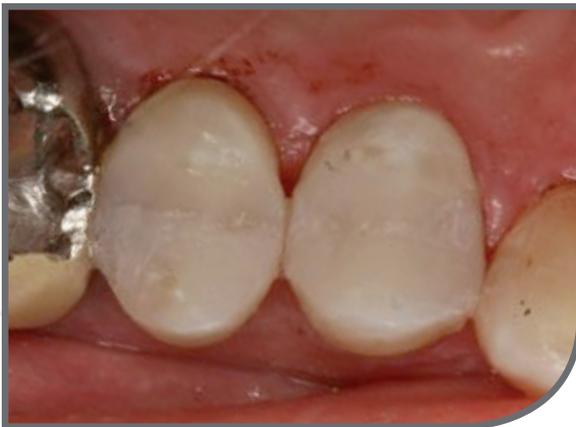
07

Fully restored teeth numbers 4 and 5. Due to size of restorations, the patient was alerted that both teeth may be candidates for full coverage in the future when the patient is more financially able.

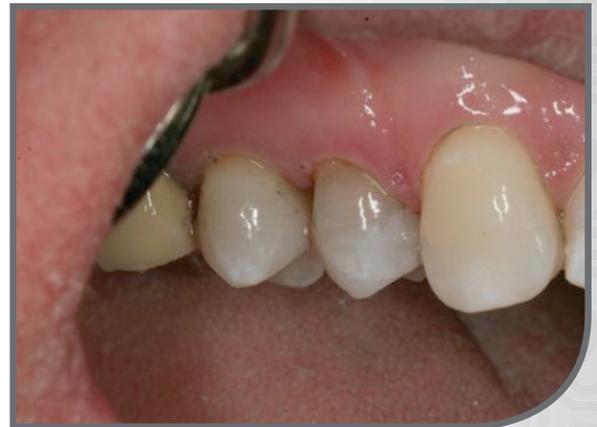
08

Buccal view of teeth numbers 4 and 5 after restoration.
