Simplifying the Unexpected: Quad Matrix for Predictable Class II Outcomes

This case demonstrates how to diagnose and restore early Class 2 defects using an advanced matrix system, specifically the Quad Matrix from Garrison, in conjunction with Shofu Bioactive composites.

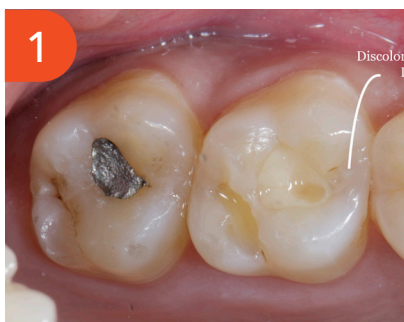
Figure 1 - Preparation extent.

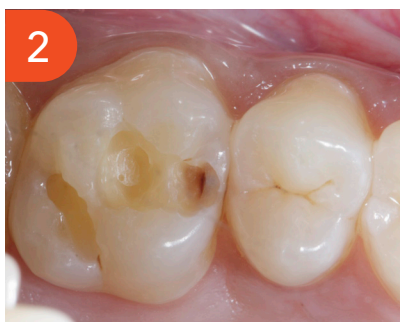
Figure 2 - After initial drilling as suspected classical Class 2 defect.

The old composite restoration on tooth #26 was carefully removed using a high-speed round bur. As we approached the mesial area, suspected decay previously noted during the clinical examination became more apparent. We proceeded to remove additional tooth structure, which confirmed the presence of a typical Class II defect as seen in Figure 2.

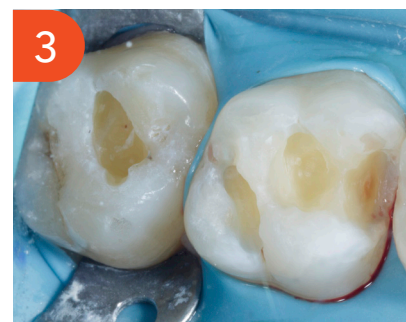
Figure 3 - Caries removal, achieving peripheral seal zone, Removing unsupported enamel. The picture was taken after air abrasion and selective etching was performed.

Finish the proximal walls with Shofu Super-Snap disks: start with the violet disk, followed by green and pink disks. This approach ensures optimal bonding to the enamel and helps prevent potential microleakage. Air particle abrasion using 25-micron aluminum oxide powder for more than 5 secs. This process cleans the cavity preparation and enhances bonding strength. Figure 3

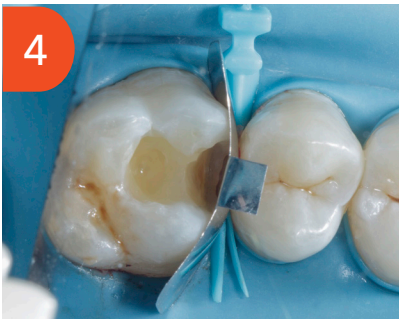
Figure 4 - Placement of FXH 200 firm band secured with the Quad blue wedge, checking the proximal seal.

The firmness of the band material facilitates easy placement and secure fitting, the bands maintain their shape and do not distort during layering the composite ensuring accurate and reliable restoration outcomes. The band is secured with a Quad blue wedge, selected based on fitting firmness - a larger wedge is chosen if the fit is loose. Proper placement involves passing both arms of the wedge to the other side. Given the Class 2 defect's location in the middle area with equal tooth structure on both sides, a buccal-to-palatal wedge placement was used, following the classical approach. Figure 4

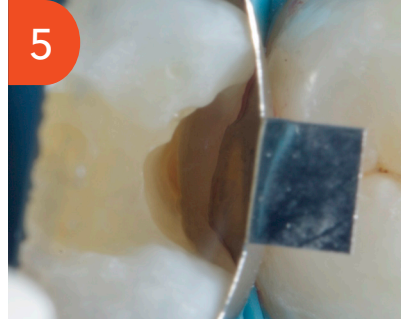
Figure 5 - Proximal Box seal before placing the Matrix Ring.

After placing securing band and wedge, carefully seen the proximal box seal, took photos to ensure 100% seal. Figure 5

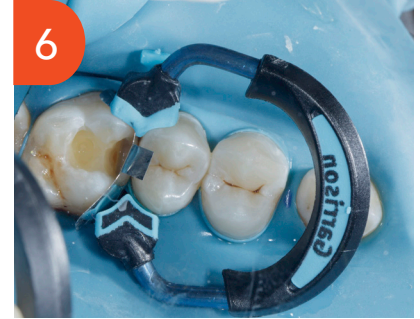
Figure 6- The Quad ring was placed with its driver tip from the buccal side.

Once the band is securely in place, the Quad ring is selected and positioned with its driver tip on the buccal side, following the placement of the wedge from the palatal. Figure 6

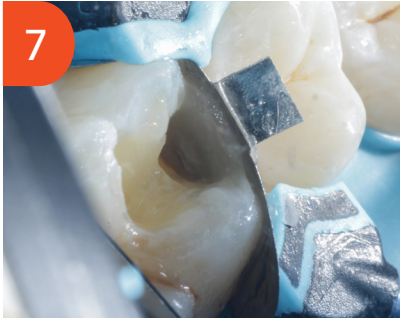
Figure 7 - Converting Class 2 to Class 1, Making the wall / marginal ridge.

Time to convert the Class 2 into a Class 1 by first creating the wall. To achieve this, we used the snow plough technique with a stress-reducing layering approach. This involved building the walls separately on the palatal and buccal sides using Shofu Injectable XSL A3O and Packable Shofu Beautifil LS II A3. Figure 7

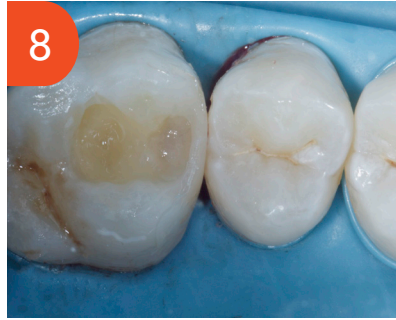
Figure 8- After removal of the Garrison quad matrix system, time for morphological layering.

After curing from all sides, the band and wedge are removed. Due to the rigidity of the band no excess flange and over contoured seen due to placing adjacent band. Figure 8

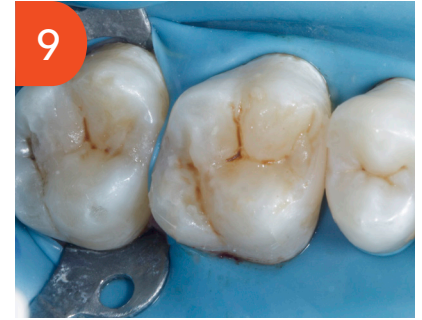
Figure 9- Morphological layering cusp by cusp.layering.

After converting to Class I, the occlusal defect of tooth #26 is restored with Shofu Beautifil LSII in shade A2 by using the cusp-by-cusp morphological layering method. Figure 9

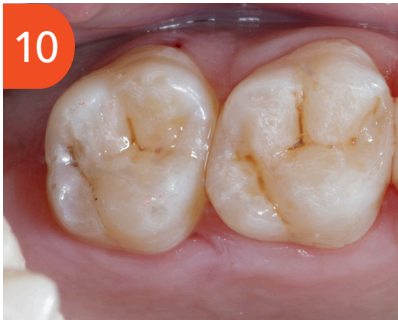
Figure 10- After removal of the rubber dam

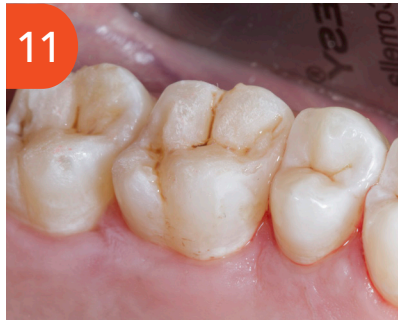
Figure 11- Different angle shows invisible restoration with ideal contours and contact and height of marginal ridge.

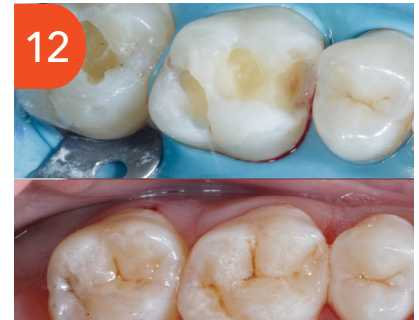
Figure 12- Before and after shows natural form and functionally restored teeth.

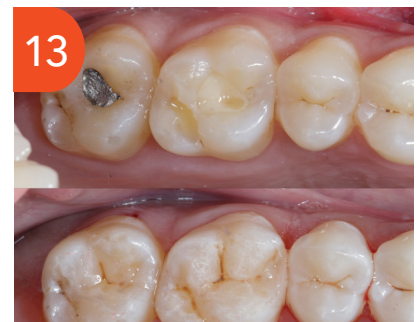
Pic 13- Before and after shows natural form and functionally restored teeth.
