Composite Restorations

Procedure/Study by

Dr. Michael Mandikos,
BDSc (Hons), MS (New York),
Cert Pros, FRACDS, FICD

Composi-Tight™ 3D

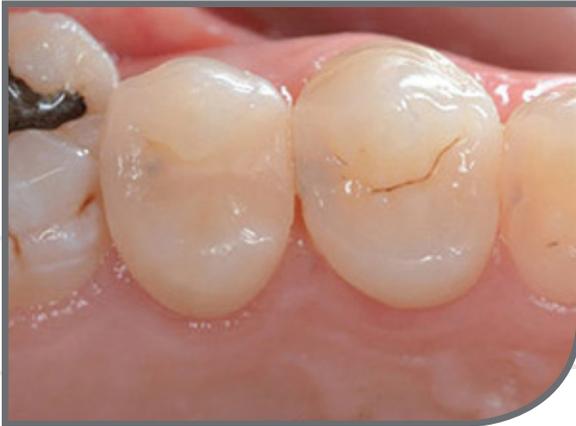
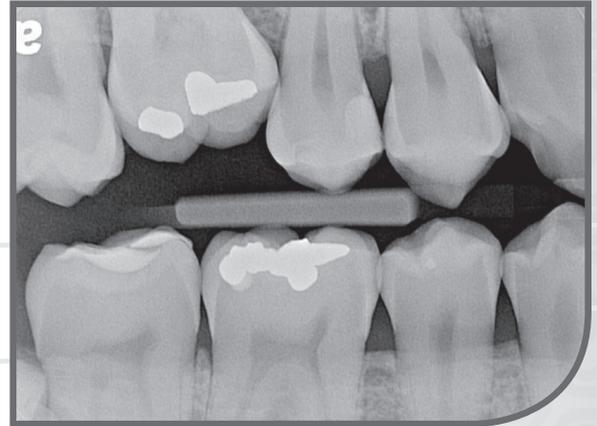
Figures 1 and 2: The patient presented for a routine checkup; it had been two years since the last examination. Bite-wing radiographs and intra-oral examination revealed caries in the distal of the first premolar and the disto-occlusal pit of the second premolar. The decision was made to restore the teeth with a micro-hybrid posterior composite.

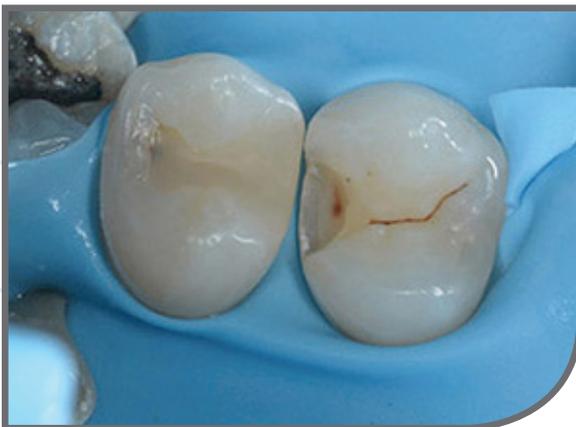
03

Figure 3: A minimally invasive cavity design was used to reach and excavate the caries in both teeth. Rubber dam isolation was applied to prevent contamination during the bonding process.

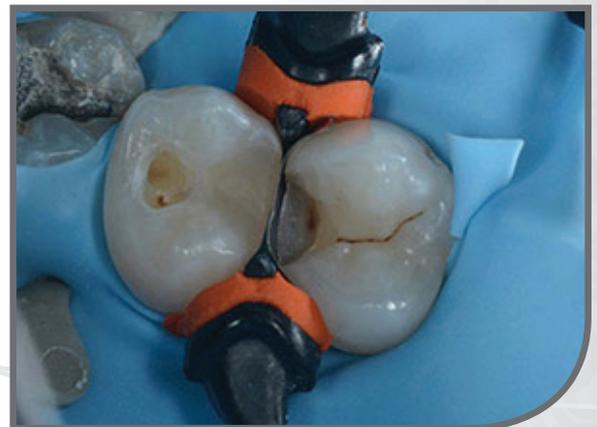
04

Figure 4: Tight, anatomical contact "zones" (as distinct from thin contact points) are required for the ideal restoration of posterior teeth, to prevent tooth movement and food packing from open and unstable contact points. A Garrison sectional matrix ring was applied to the first premolar to ensure a perfect contact was achieved.

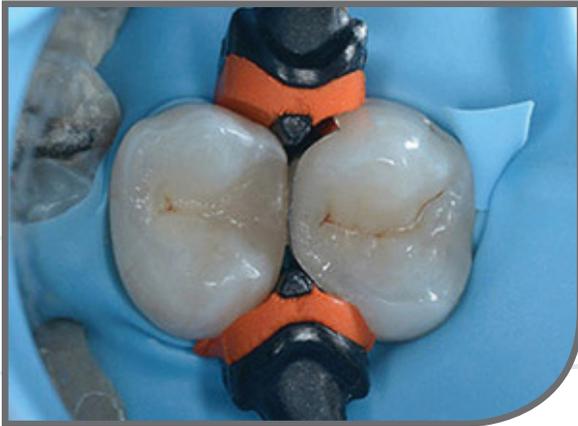
05

Figure 5: The teeth were then restored with an etch and rinse (fourth generation) adhesive, a flowable composite liner, and a microhybrid composite. The burnished Garrison sectional matrix band ensured an excellent "contact zone" that was tight against the second premolar.

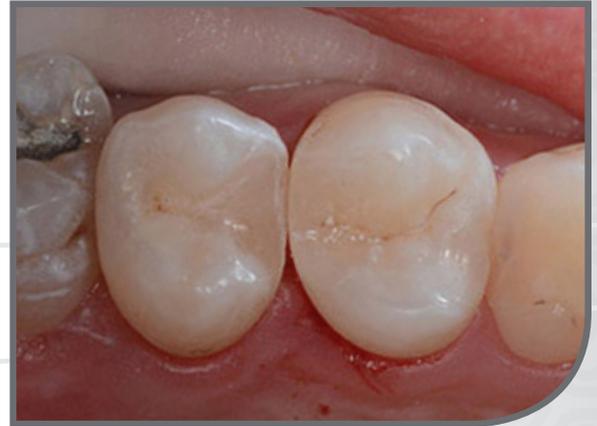
06

Figure 6: The final post-operative outcome, following debanding, polishing, and removal of the rubber dam. An excellent anatomical form was achieved in combination with tight, broad contacts.
