A Minimally Invasive Strategy for Restoring Complex MOD Defects with the Quad Matrix System

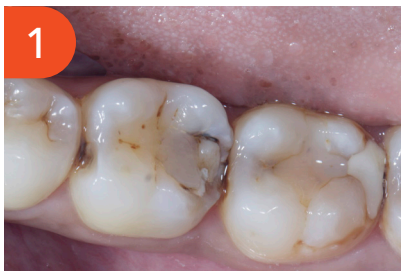
Image 1: Multiple defects starting from tooth #45 to #48 as described.

Clinical examination showed significant mesio-occluso-distal (MOD) defects and Class 2 affecting teeth from #45 to #48.

Clinical examination revealed a mesial proximal carious defect with complete loss of the marginal ridge. On the distal aspect, an old composite restoration was observed, appearing underfilled and extended onto the occlusal surface. Evident marginal leakage and localized chipping were present along the restoration interface. Additionally, unsupported enamel was noted on the distobuccal cusp, indicating structural compromise and the risk of cusp fracture.

An existing occlusal composite restoration demonstrated marginal discoloration and leakage. The distal surface exhibited a composite material of a different shade and texture, suggestive of a restoration placed at a later date. Lack of a defined marginal ridge resulted in an improper proximal contact. On the mesial surface, dark discoloration contiguous with the existing mesial pit composite indicated the presence of a recurrent or active Class II carious lesion.

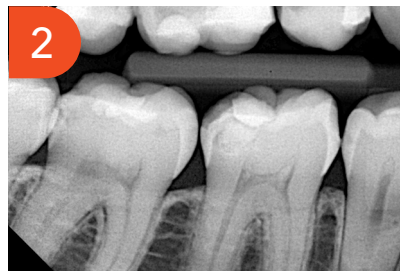
Image 2: Multiple class 2 defects starting from tooth #45 to #48 with loss of ideal contacts and contours.

Bitewing radiograph confirmed the presence of multiple MOD / Class II carious lesions corresponding to the clinical findings. None of the defects demonstrated radiographic proximity to the pulp.

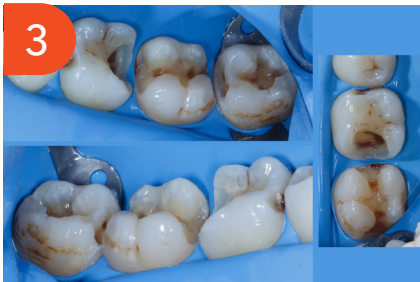
Image 3: Preparations for #46, #47, and #48 focused on removing caries, establishing a peripheral seal zone, eliminating unsupported enamel, and refining the proximal box.

Caries-disclosing dye was utilized to aid in complete removal of carious tissue and residual composite material in teeth #48, #47, and the distal surface of #46. Infected dentin was carefully excavated using a slow-speed round carbide bur. Establishing a well-defined peripheral seal zone, free from infected and affected dentin, was prioritized to ensure maximum bond strength.

On tooth #46, the distobuccal cusp was selectively reduced until sound, supported enamel and dentin were achieved. For tooth #48, a conservative tunnel preparation was performed on the mesial surface to preserve the integrity of the marginal ridge. All cavity preparations were subsequently refined using a superfine (yellow-band) diamond bur to remove unsupported enamel. Additionally, abrasive finishing discs were used to further eliminate any remaining unsupported enamel and to smoothen the cavity walls.

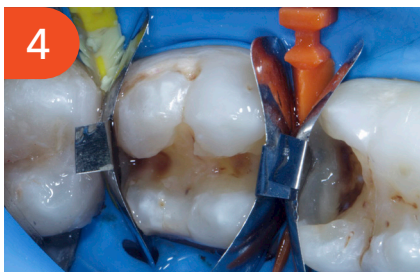
Image 4: Following the restoration of tooth #48, Garrison sectional matrix bands were placed and stabilized using wedges.

The first sectional band (FXH 175) was positioned at the distal defect of tooth #47. Due to the minimal interdental space between teeth #47 and #48, a Strata-G yellow wedge was used to secure the matrix (Image 04). The firm structure of the wedge enabled smooth insertion in the tight interproximal area.

Subsequently, an identical band was placed between teeth #47 and #46. The quad orange wedge was slightly repositioned to allow band insertion beneath it. After band placement, the wedge was reinserted from the buccal aspect to its full seating, and gentle finger pressure ensured secure stabilization of both bands under the wedge (Image 04).

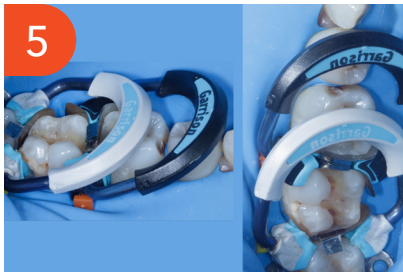
Image 5: Quad Blue ring placed between teeth #46 and #47 & Strata G ring stacked Region between teeth #48 & #47, saving precious time without compromising any contacts and contours.

A Quad Universal Ring (blue) was then applied between teeth #46 and #47. This ring, in conjunction with the quad wedge, provided a tight seal, controlled excess material, and established a natural proximal contact (Image 05). Following this, a Strata-G ring was positioned between teeth #48 and #47, stacked over the quad ring to simultaneously manage adjacent restorations effectively (Image 05).

This sequential matrix-ring configuration enabled efficient restoration of multiple proximal defects while preserving proximal contacts and occlusal morphology. The Garrison matrix system proved particularly advantageous in MOD situations due to its stability, anatomical accuracy, and time efficiency.

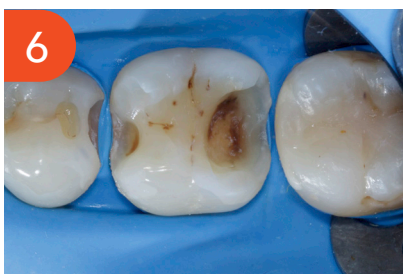
Image 6: Appointment 02, caries removal from mesial side of #46 and #45 distal and finishing of Mesial side of tooth #47.

The patient was recalled after a few days to complete the restoration of the remaining defects. Caries excavation was performed on the mesial surface of tooth #46 and the distal surface of tooth #45. Cavity preparation followed the same protocol previously described for the other teeth. The restoration on tooth #47 had been fully finished and polished during the previous appointment to ensure ideal proximal contact and contour, thereby facilitating accurate contact formation for subsequent restorations (Image 06).

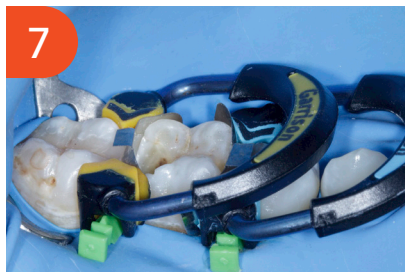
Image 7: Stacking for Quad Rings for MOD defect on tooth #46.

Restoration of the MOD defect on tooth #46 was then initiated. The use of stacked Quad rings once again facilitated accuracy and predictability in achieving ideal proximal form. FXH175 firm sectional matrix bands were positioned and stabilized using a quad green wedge inserted from the buccal aspect. After confirming an adequate seal of the proximal box, the first blue Quad ring was placed, followed by an orange Quad ring to enhance separation and matrix stability (Image 07, 08).

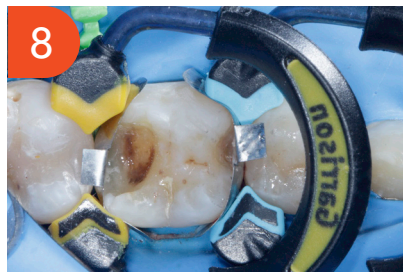
Image 8: Restoring #45, Quad rings (Blue & orange) are stacked, checking the proximal box seal.

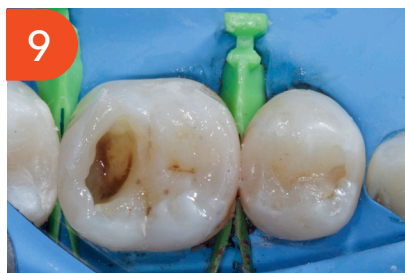
Image 9: Restoring #46 mesial defect and distal wall in stress reducing layering in two increment, one buccal and one lingual, converting MOD to Class, Bands are removed for final restoring the distal defect.

Given the large size of the distal wall defect, the proximal wall was built in two increments—first from the buccal side and then from the lingual. This incremental approach was selected to minimize polymerization shrinkage stress. Once the walls were completed, the matrix bands were carefully removed. Notably, no excess composite flange or flash was observed, demonstrating the precision and sealing efficiency of the Garrison Quad Matrix system (Image 09).

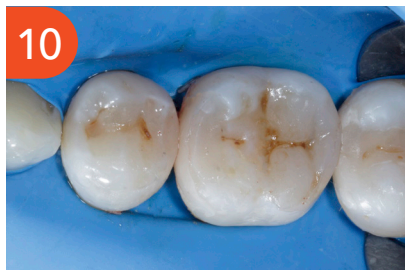
Image 10: Before removal of rubber dam.

Due to large defect on distal side we decided to use short fiber composite followed Shofu Beautifil LS II packable as a final layer. All the layer placed incrementally in order to reduce shrinkage stress. Stains have added to make restoration look like more natural. The contours and embrasures were well established and finished using a Shofu Super Snap purple disk. The oxygen inhibition layer was removed using sodium bicarbonate powder with an air polisher unit (image 11).

The rubber dam was removed, and high points were checked using 40-micron paper, followed by 8-micron foil in static occlusion. For dynamic occlusion, 200-micron paper was used, and adjustments were made to the cuspal slopes and non-functional cusps.

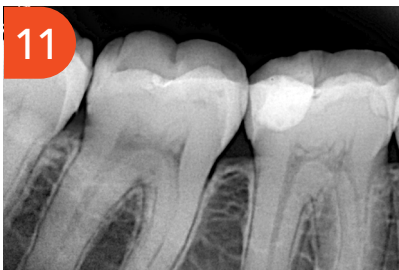
Image 11: IOPA to check no overhangs.

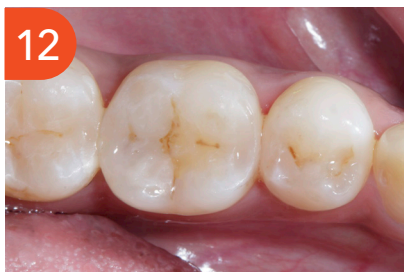
Image 12: Post op after 15 days.

The quadrant restorative approach using the Garrison Quad Matrix System allowed precise reconstruction of proximal contacts, anatomical contour, and occlusal morphology in multiple adjacent Class II lesions. By first converting extensive MOD cavities into controlled Class I preparations through incremental wall build-up, polymerization shrinkage stress was minimized and tooth structure was preserved. The combination of Shofu Injectable XSL and Beautifil LS II packable composites, along with selective use of short-fibre composite, provided excellent marginal adaptation and structural reinforcement. This technique proved to be highly predictable, time-efficient, and minimally invasive, making it an ideal protocol for restoring multi-surface posterior defects while ensuring long-term functional stability and aesthetics.

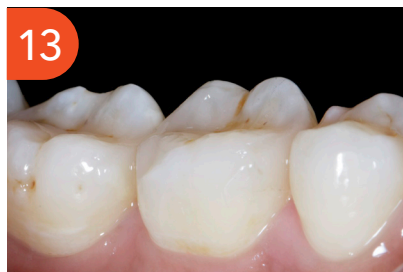
Image 13: Buccal view, Post of after 15 days shows healthy gums with papilla filled with ideal contacts and contours.

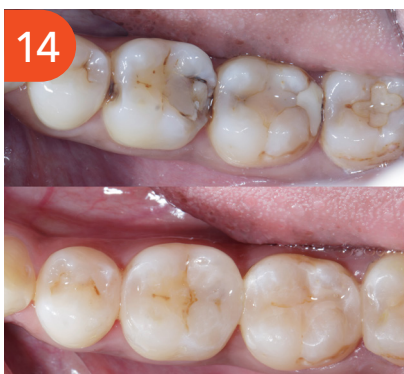
Image 14: Before and after showing close to natural contacts / contours.

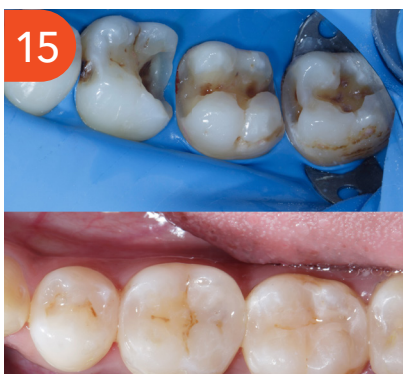
Image 15: Showcasing extent large defect restored back to its natural form and function.

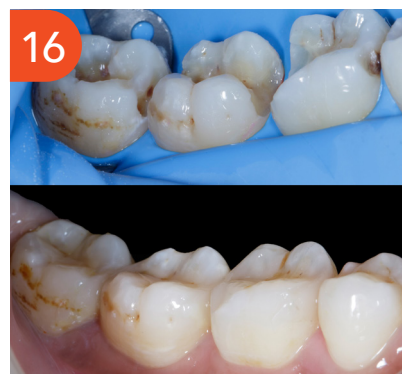
Image 16: Buccal view - Showcasing extent large defect restored back to its natural form and function.
